Use of Wood in the Construction Tradition of a 17th-Century Church in Southern Brazil

Eder Karpovicz Andrade

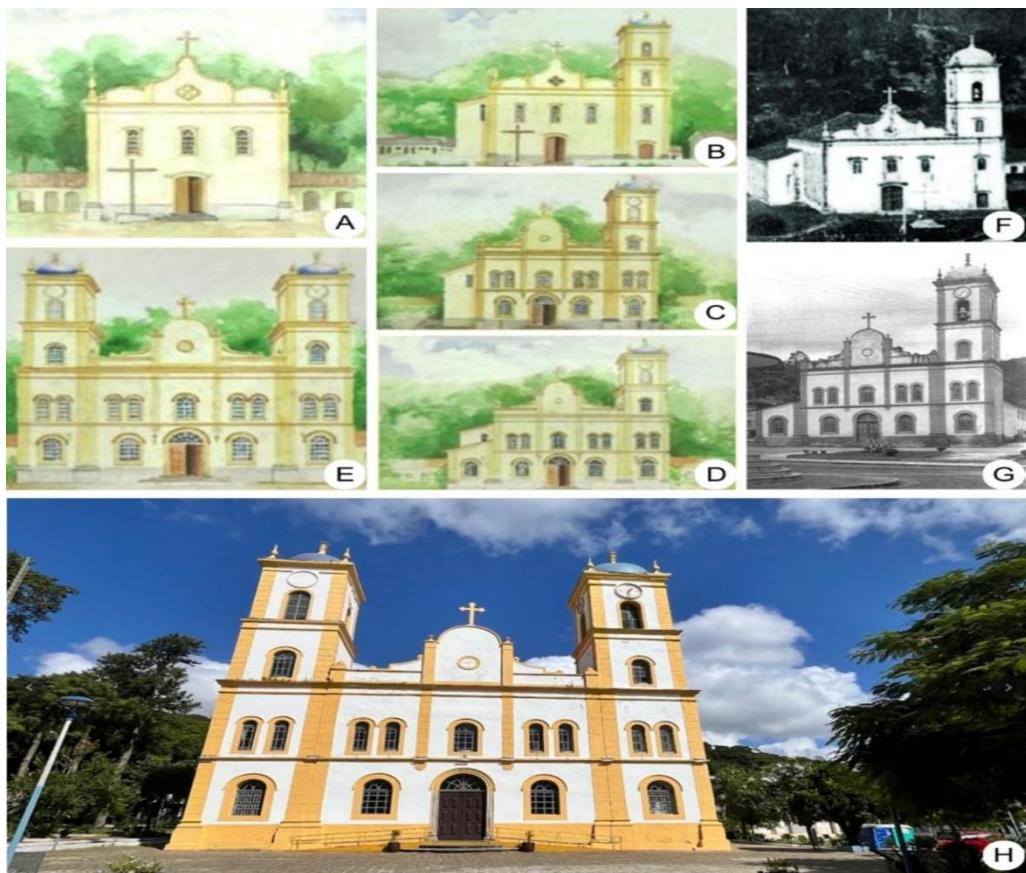
Figure 2. Temporal evolution of the façade of the Igreja Matriz Nossa Senhora da Graça, São Francisco do Sul, Santa Catarina State, Southern Brazil. Caption: A -year 1665. B and F -year 1783. C -year 1926. D and G -1950. E -year 1965. H -Present day. Source: Historical archive, adapted by the author.the influence of Western architecture, put forward new requirements.

Originally conceived in Renaissance Venetian style, the church was built by enslaved people who used materials such as stone, lime, and oil in its construction. The roof structure is made of wood and has undergone several renovations over the years (Amorim, 2020). Initially, when the church was conceived in 1658, the project did not include any towers; during construction, only one tower was built, and over the years, the building underwent several modifications, including the construction of a second tower (Amorim, 2020) (Figure 2).

It is evident that even when the church had only one tower, changes were made to its façade, such as the addition of windows and other ornamental details (Figure 2C – D). The current façade, with two towers and constructive details (Figure 2E and H), represents the finalized version of the church after the restoration carried out in the second half of the 1960s.

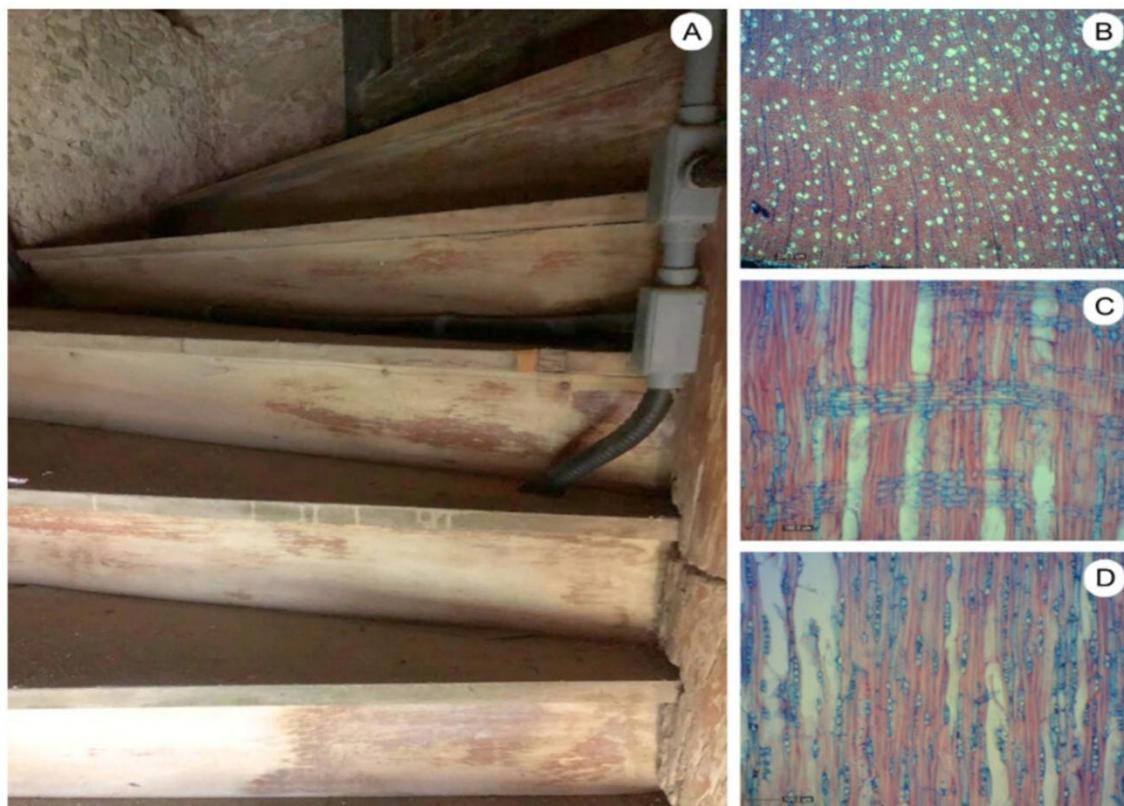
Aspidosperma sp. -Apocynaceae (Figure 5)

Figure 5. Constructive element and respective wood anatomy of *Aspidosperma* sp. (Apocynaceae), Nossa Senhora da Graça Church, São Francisco do Sul, Santa Catarina State, Southern Brazil. Caption: (A) Bell tower staircase steps. (B) Transverse section. (C) Radial longitudinal section. (D) Tangential longitudinal section.

Growth ring: distinct, demarcated by fiber wall thickening and marginal bands of axial parenchyma. Vessels: diffuse-porous; solitary; tangential diameter $\leq 50 \mu\text{m}$; frequency ≥ 100 vessels/mm 2 ; length 350–800 μm ; simple perforation plates; alternate, minute intervacular pits $\leq 4 \mu\text{m}$; ray–vessel pits with distinct borders, similar in size and shape to intervacular pits; gum deposits present. Fibers: simple to minute pits; non-septate; thin- to thick-walled; length 900–1600 μm . Axial parenchyma: apotracheal diffuse and diffuse-in-aggregates; fusiform series

with 3–4 to 5–8 cells. Rays: uniseriate, homogeneous; 4–12 rays/mm.

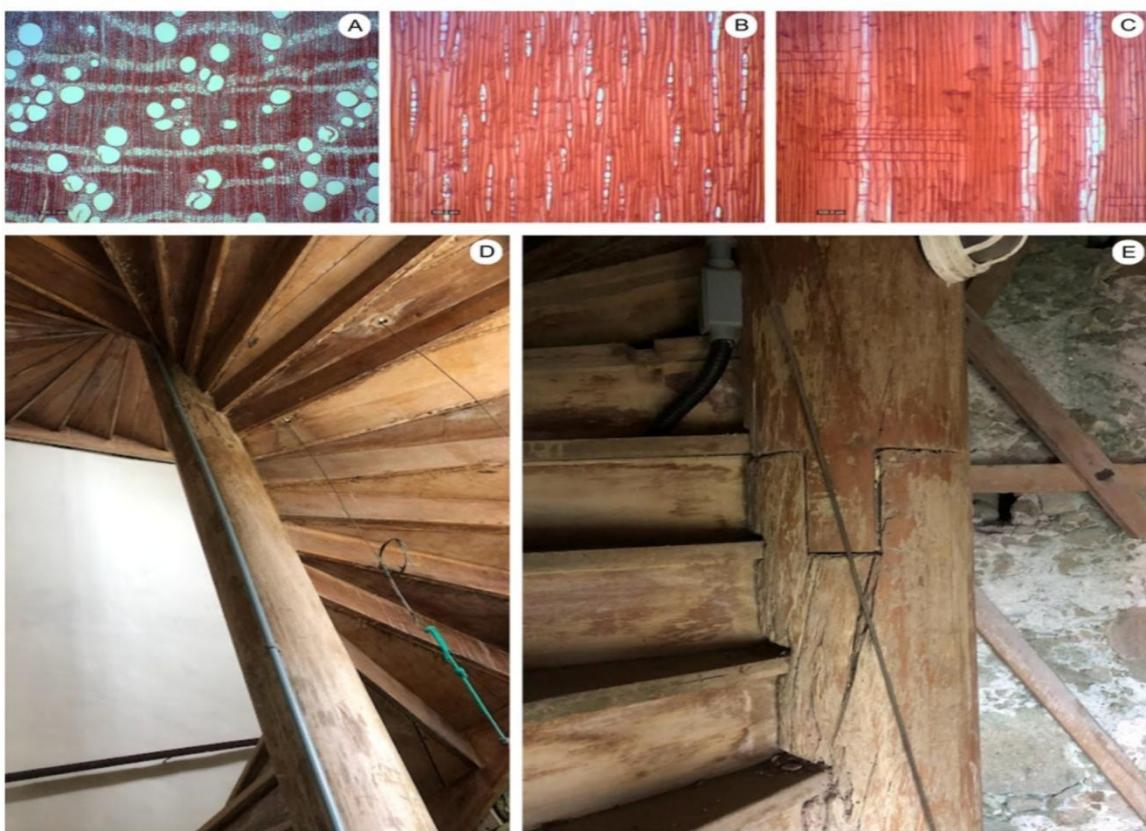
Calophyllum brasiliense -Calophyllaceae (Figure 6)

Figure 6. Constructive element and respective wood anatomy of *Calophyllum brasiliense* (Calophyllaceae), Nossa Senhora da Graça Church, São Francisco do Sul, Santa Catarina State, Southern Brazil. Caption: (A) Transverse section. (B) Radial longitudinal section. (C) Tangential longitudinal section. (D-E) Pillar of the bell tower structure.

Growth ring: indistinct. Vessels: diffuse-porous, arranged diagonally; solitary and in pairs; tangential diameter 100–200 μm ; frequency 5–20 vessels/ mm^2 ; length $\leq 350 \mu\text{m}$; simple perforation plates; alternate small intervacular pits (4–7 μm); ray – vessel pits apparently simple, with reduced, rounded, or angular borders; vasicentric tracheids present; tyloses common. Fibers: simple to minute pits; non-septate; thin- to thick-walled; 900 – 1600 μm long. Axial parenchyma: apotracheal diffuse, diffuse-in-aggregates, paratracheal aliform and confluent; fusiform series with 5–8 cells. Rays: 1–3-seriate, heterogeneous; ≥ 12 rays/mm. Prismatic crystals present in axial parenchyma chambers.

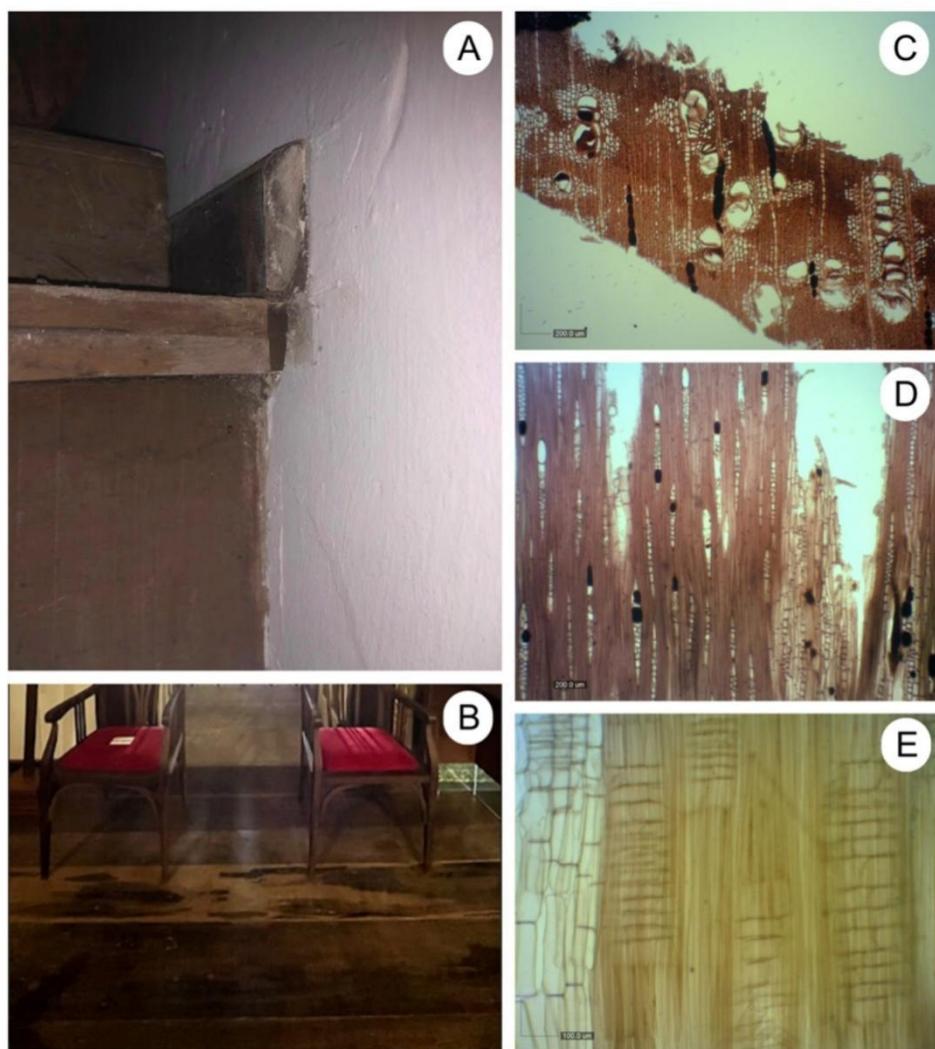
Ocotea cf. cymbarum -Lauraceae (Figure 9)

Figure 9. Constructive element and respective wood anatomy of *Ocotea* cf. *cymbarum* (Lauraceae), Nossa Senhora da Graça Church, São Francisco do Sul, Santa Catarina State, Southern Brazil. Caption: (A) Floorboard. (B) Mezzanine flooring. (C) Transverse section. (D) Radial longitudinal section. (E) Tangential longitudinal section.

Growth ring: indistinct. Vessels: diffuse-porous; solitary and in groups of 2–5; tangential diameter 100–200 μm ; frequency 5–20 vessels/ mm^2 ; length 350–800 μm ; simple perforation plates; alternate medium intervacular pits (7–10 μm); ray–vessel pits with reduced or simple borders, rounded or angular; tyloses common. Fibers: simple to minute pits; non-septate; thin- to thick-walled; 900–1600 μm long. Axial parenchyma: paratracheal vasicentric, aliform, aliform-lobate, and confluent; fusiform series with 3–4 cells. Rays: 1–2-seriate, heterogeneous, with procumbent body and 1 marginal row of square or upright cells; 4–12 rays/ mm . Oil cells associated with ray cells.

The identification of *O. cf. cymbarum* among the woods used in the building is noteworthy, as this is typically an Amazonian species (Lorenzi, 1992). Its occurrence in a structure located in southern Brazil raises the hypothesis that these pieces may have been reused from previous constructions, possibly dismantled ones, since the wooden structures underwent restoration in the early 2000s.

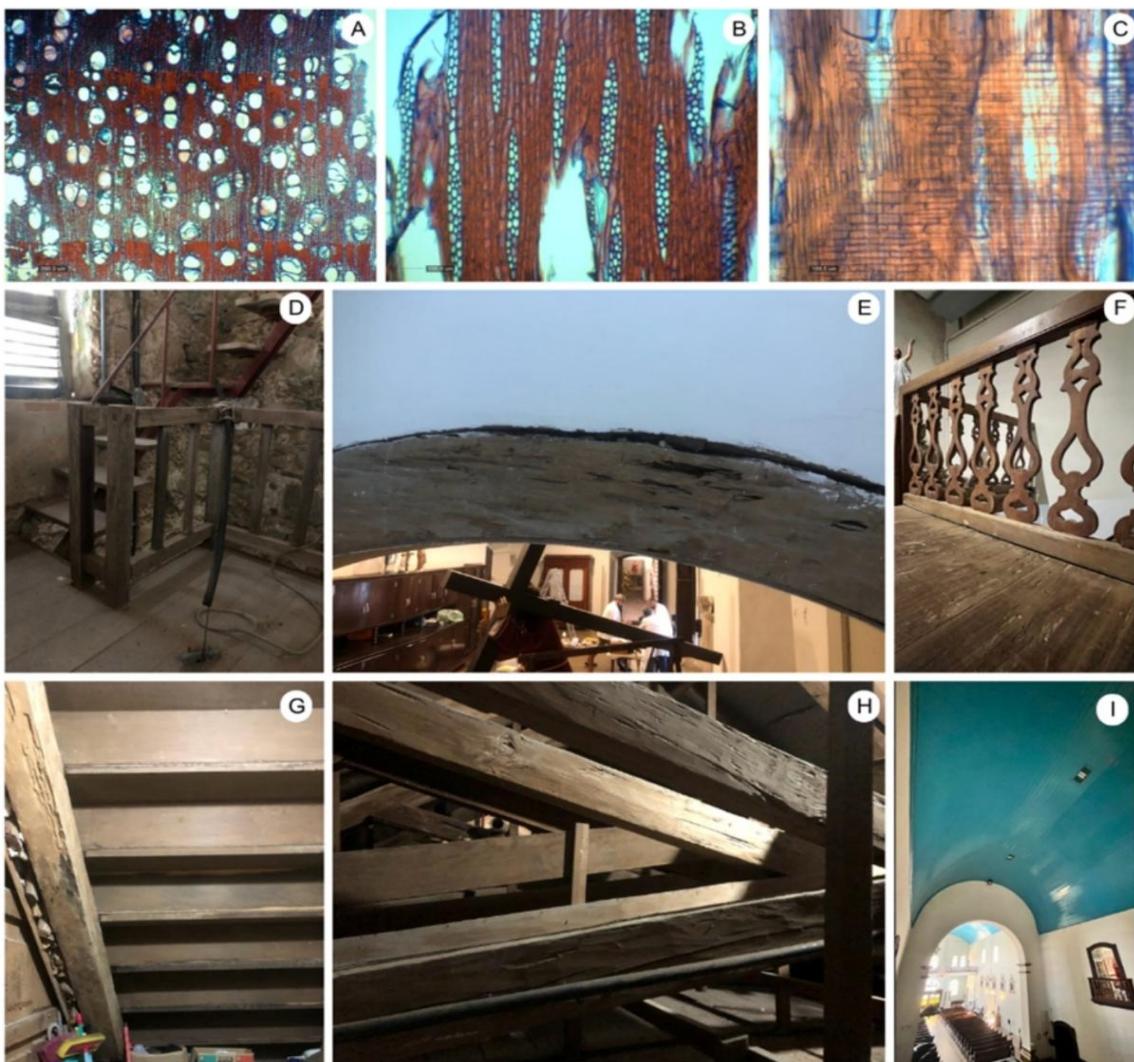
Ocotea porosa -Lauraceae (Figure 10)

Figure 10. Constructive element and respective wood anatomy of *Ocotea porosa* (Lauraceae), Nossa Senhora da Graça Church, São Francisco do Sul, Santa Catarina State, Southern Brazil. Caption: (A) Transverse section. (B) Radial longitudinal section. (C) Tangential longitudinal section. (D) Bell tower railing. (E) Sacristy access frame. (F) Baluster of the museum railing. (G) Step below the sacristy staircase. (H) Roof truss (old piece). (I) Roof lining.

Growth ring: distinct by fiber wall thickening. Vessels: diffuse-porous; solitary and in groups of 2 – 3; tangential diameter 100 – 200 μm ; frequency 5 – 20 vessels/ mm^2 ; length \leq 350 μm ; simple perforation plates; alternate medium intervesselary pits (7 – 10 μm); ray – vessel pits apparently simple, with reduced, rounded, or angular borders; tyloses common. Fibers: simple to minute pits; septate and non-septate; thin- to thick-walled; 900 – 1600 μm long. Axial parenchyma: paratracheal scanty; fusiform series with 3 – 4 cells. Rays: 1 – 3-seriate and 4 – 10-seriate; 4 – 12 rays/ mm . Oil cells associated with ray cells.

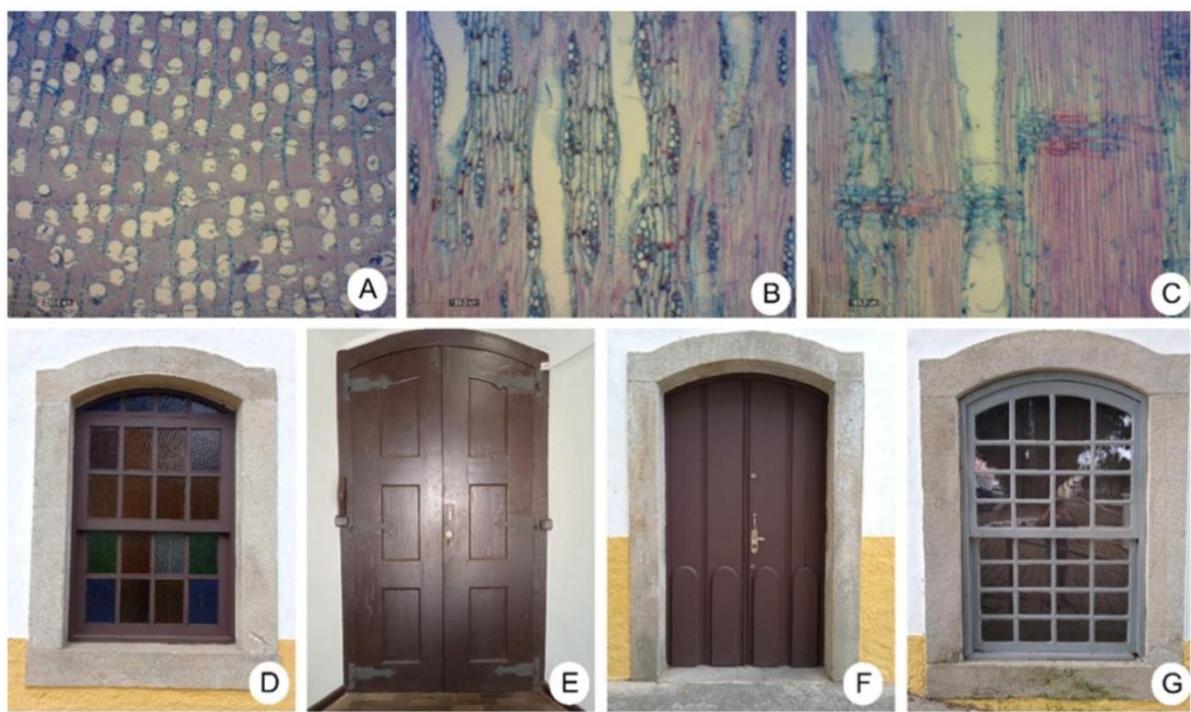
Handroanthus sp. -Bignoniaceae (Figure 12)

Figure 12. Constructive element and respective wood anatomy of *Handroanthus* sp. (Bignoniaceae), Nossa Senhora da Graça Church, São Francisco do Sul, Santa Catarina State, Southern Brazil. Caption: (A) Transverse section. (B) Radial longitudinal section. (C) Tangential longitudinal section. (D - G) Frames present in the building

Growth rings: distinct, delimited by radial thickening of fiber walls; vessels mostly solitary and in pairs; tangential diameter 50–100 µm; frequency 5–20 vessels/mm²; simple perforation plates; alternate, polygonal, large intervacular pits ≥ 10 µm; ray–vessel pits similar in size and shape.

Fibers: simple to minute pits; non-septate; thin- to thick-walled. Axial parenchyma: paratracheal unilateral; fusiform series with 3–4 cells. Rays: 2–3-seriate, stratified, heterogeneous, with procumbent body and one marginal row of square or upright cells; 4–12/mm.
